Joining the Dots – 2020 Update

Problem Recognition, Research, Guidelines, Implementation, Reporting and Assurance

April 2020

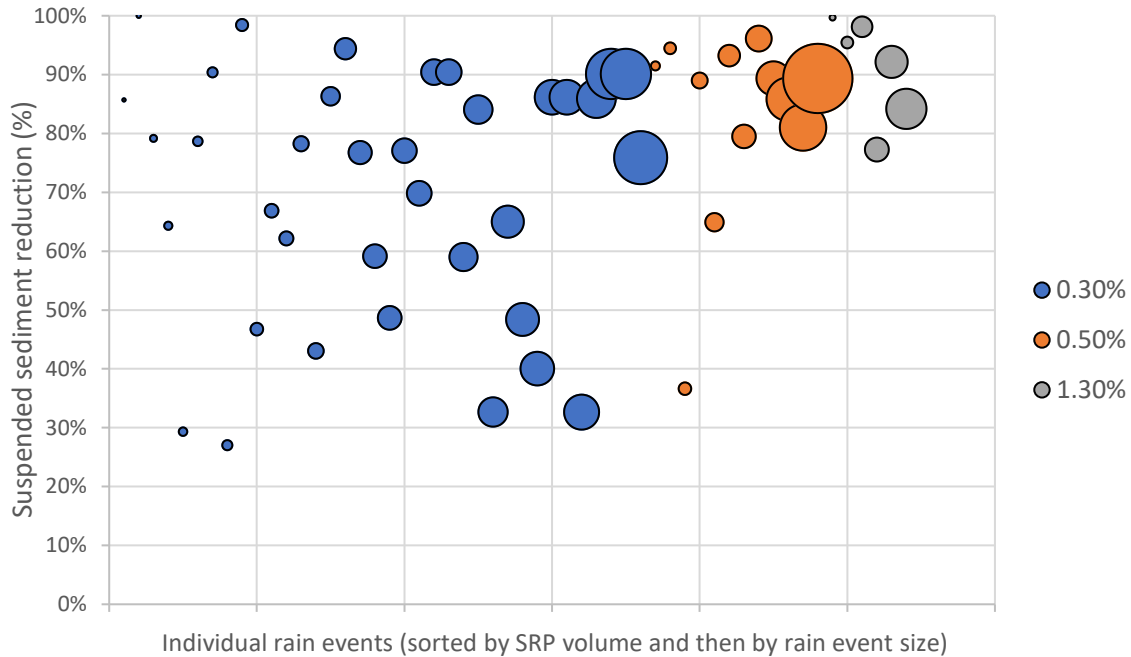
Figure 2. Summary of 4 years of SRP trials - proportion of suspended sediment removed by different sized SRPs. The colour of each bubble refers to the size of the SRP as a percentage of its catchment area, whilst the size of the bubble indicates the relative size of the rainfall event.

The main output of the project was understanding the effectiveness of different sized Sediment Retention Ponds (SRPs). The results are shown in Table 1 and Figure 2 below. These results supported the existing guideline (*Erosion & Sediment Control Guidelines for Vegetable Production*, Barber 2014) specifications for a minimum size of SRPs on cultivated horticultural land of 0.5% (50 m³/ha).

The main outcomes of the SRP efficiency trial were:

- The existing minimum size of SRPs at 0.5% (50m³/ha) detailed in *Erosion & Sediment Control Guidelines for Vegetable Production* (Barber, 2014) were supported by the data gathered from this trial.

- Undersized SRPs (<0.5%) detain almost all (>99%) bedload erosion, which itself comprises around 95-98% of total erosion. The size of an SRP is therefore dictated by suspended sediment reduction efficiency, which increases as the ponds become larger.

- While undersized SRPs were extremely effective at bedload capture, they become inundated during storms or over winter when they can not be cleaned out.

- The 0.5% SRP had an average total sediment reduction efficiency of 88%. The median suspended sediment concentration in the discharge water was 130 g/m³.

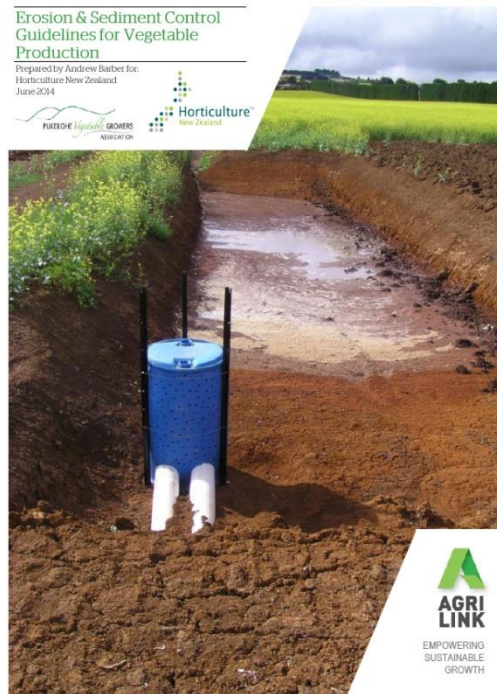
The Erosion & Sediment Control Guidelines for Vegetable Production¹ was prepared in 2014 and specifies the four-step process needed to conduct an E&S risk assessment and to generate a mitigation plan. The guidelines details a large array of E&S control measures suitable for cultivated horticultural land. Measures detailed in the guideline include vegetated buffers, sediment retention ponds (SRPs), cultivation practices, interception drains, and wheel track ripping amongst many others. These guidelines specify the minimum standards for construction and maintenance SRPs.

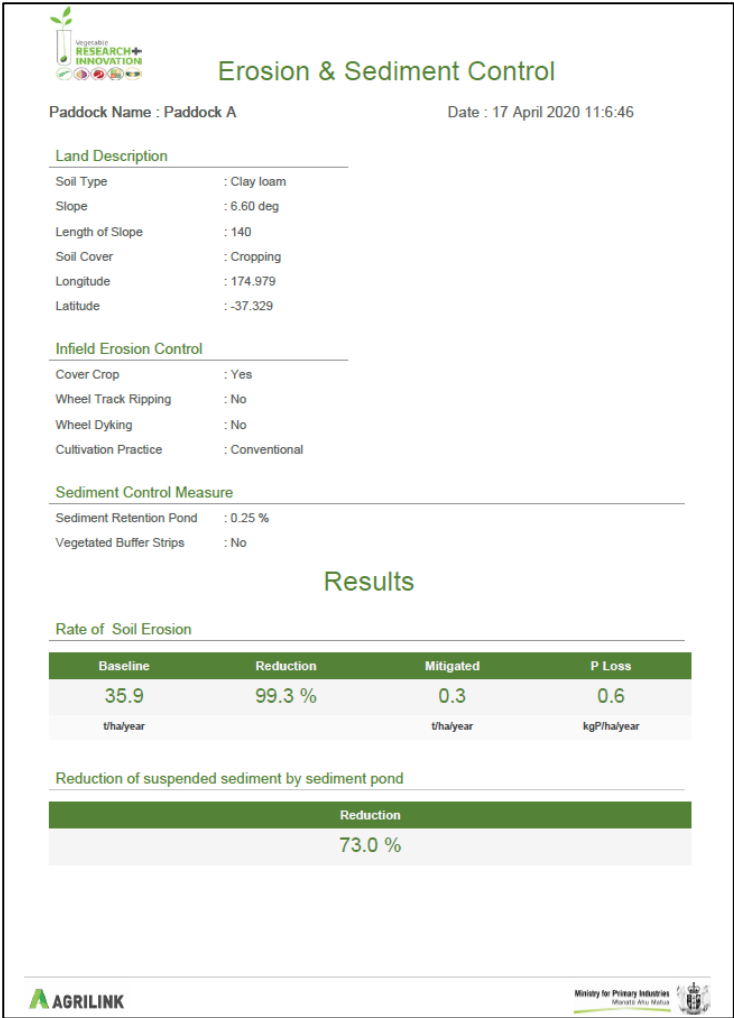
Figure 3. The output report from the DMTW App.

- The DMTW App has been developed to help in the risk assessment process when preparing an E&S Control Plan. The app calculates unmitigated and mitigated erosion and sediment loss rates using the Revised Universal Soil Loss Equation (RUSLE), as well as the trial results.

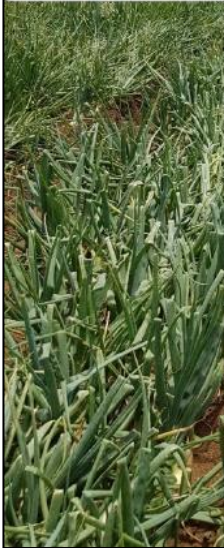
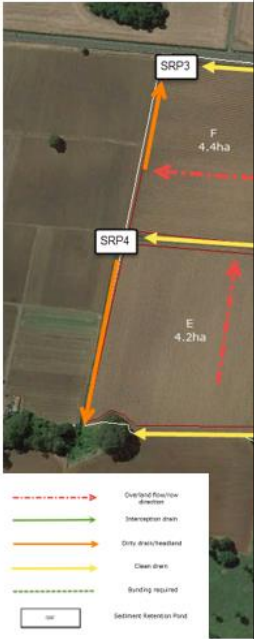
Figure 1. Current paddock map.

Figure 4. Example E&S Control Plan.

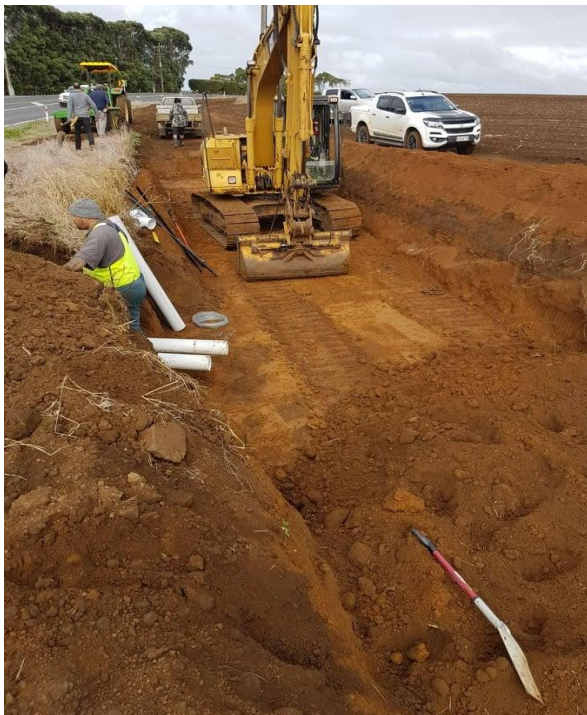
Figure 5. Construction of an SRP following the E&S Control Plan.

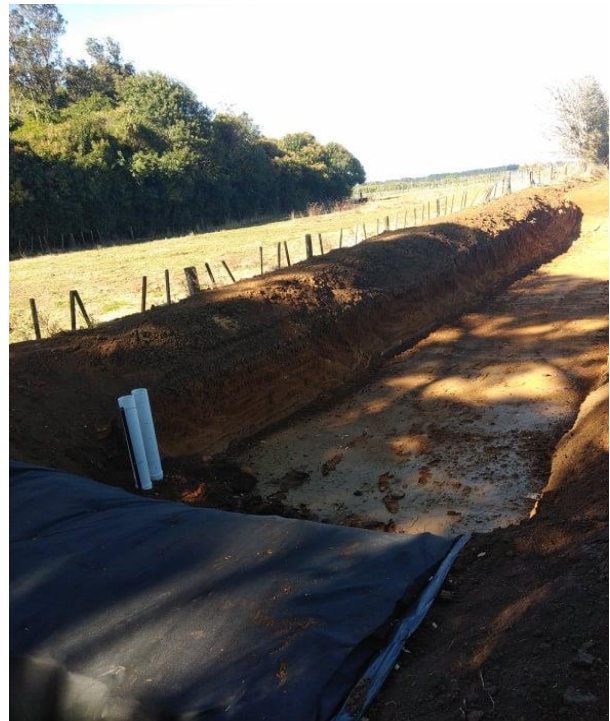
Figure 6. A completed 0.5% SRP. The important elements being volume, snorkels, and a protected level emergency spillway.

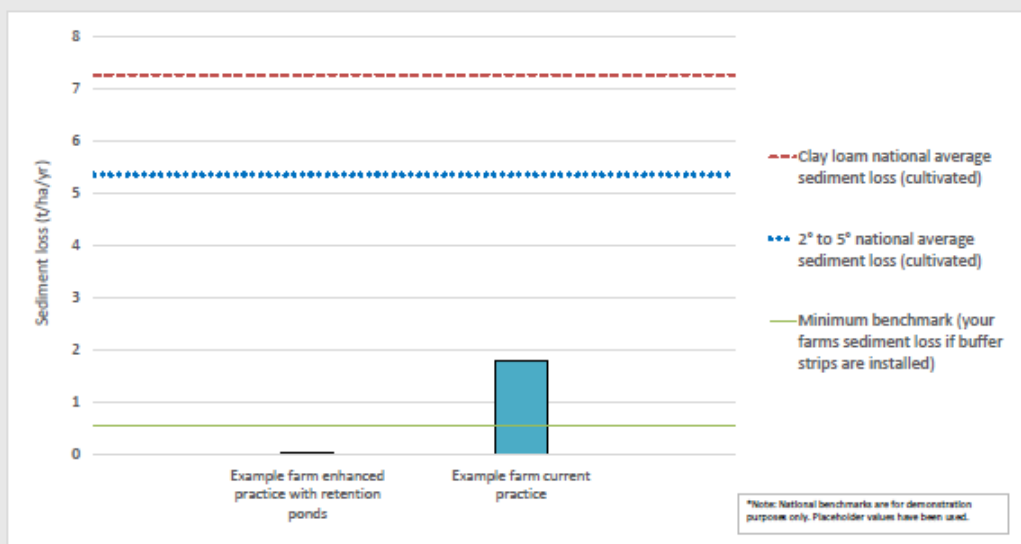
Figure 8. Individualised E&S Control benchmarking report.

Individualised erosion and sediment benchmarking reports have been developed. The reports are generated in Excel and exported as individualised 1-page pdfs.

Paddock descriptions, GMPs, and erosion and sediment loss rates are imported into Excel as a csv file, having been (at this stage) exported from Formstack. Grower details are imported from the NZGAP database.

The metrics used in the report include unmitigated erosion rates, along with current and future enhanced practice sediment loss rates. Enhanced practice is based on the use of cover crops, wheel track ripping, vegetated buffer strips or SRPs. The benchmarks are tuned for slope, location, and soil type. There is a link in the report through to the E&S Control Guidelines on the HortNZ website.

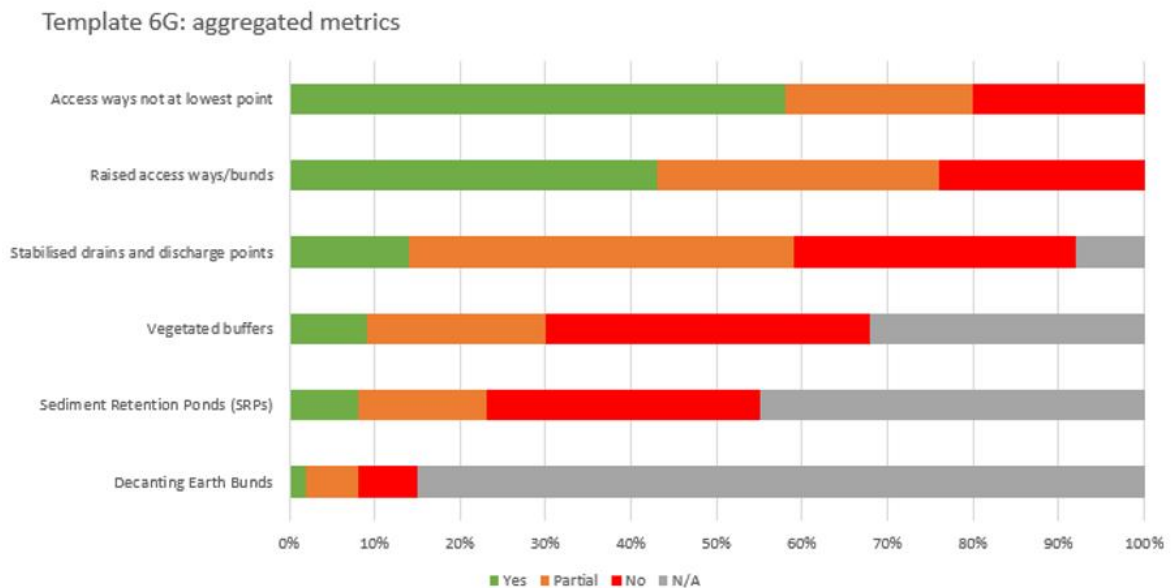
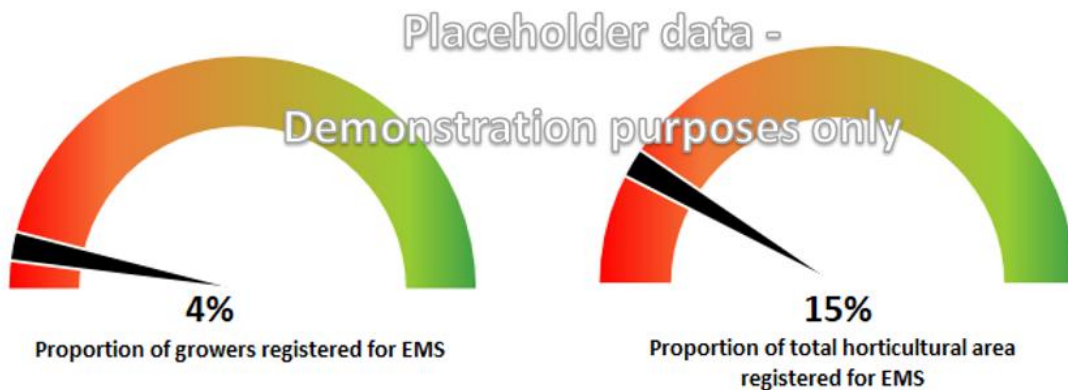
Figure 9. Dashboard report showing the aggregated adoption of sediment control measures to manage the water and suspended solids that move off paddocks.

Figure 9 shows an example of what aggregated E&S Control GMP data could look like.
